Visual Inspection Report

Manufacturer: BB/TI

Part Number: DRV101T

Date/Time: 2008-01-25

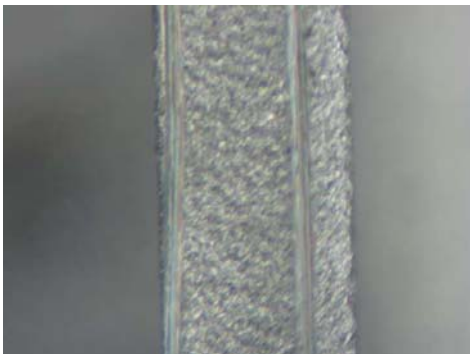
Observations: Found all 5pcs have a coating.

Coating on the leads

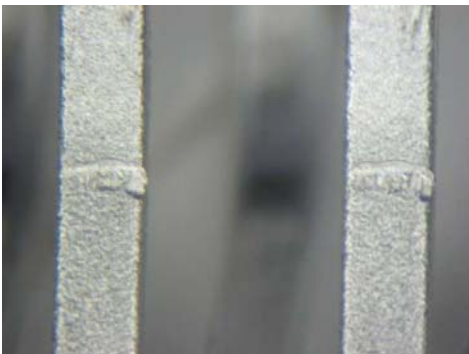
Minor Damage on the leads

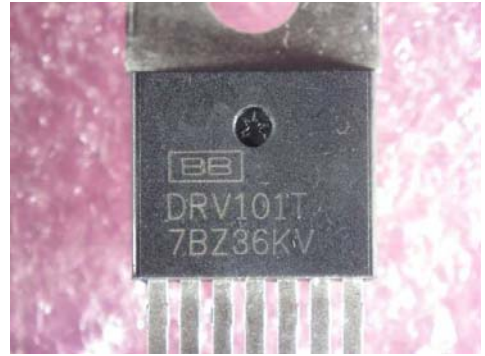
After chemical test

The parts passed on the chemical test.
